**SAS Superstructure**

Location: 04-SF-80-13.2 / 13.9

Daily Diary Report by Bid Item

Diary #: 416 Const Calendar Day: 462 Date: 09-Sep-2013 Monday

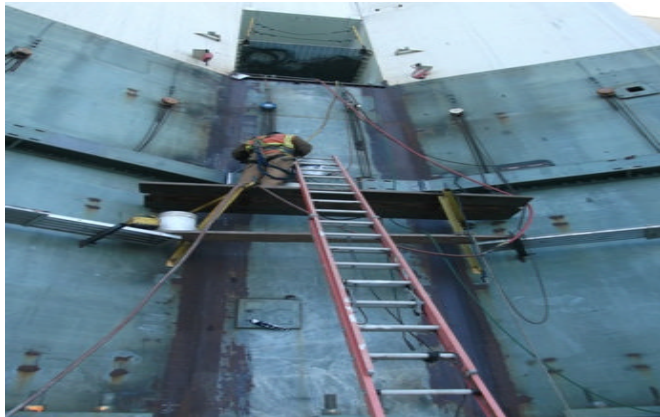
RingBeamWelding-North (2)

On the North side of the Tower, Rick Claiborne was placing butt welds on the flanges of the ring beam meeting close to the ESW joints "N" and "W". He began on the butt weld closest to ESW joint "W" and finished off by welding the flangs closest to ESW joint "N". While the welds were complete, the runoff tabs remained in place and the weld on the webs had not been cleaned up either. Ed Leach (QA) will inspect these welds once the welds are complete and cleaned-up.

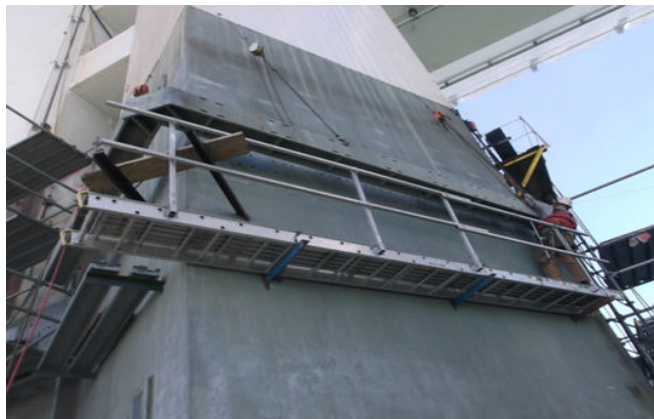
InstallRingBeam)

Sami Daouk concentrates on the structural items, while I (Laraine) would take care of the painting and welding operations. Reflected on this daily report; however, is the entire work force at the Tower base, including the crews watched by Sami Daouk. Please refer to Sami Daouk's report for all the details regarding the installation of the Ring-beam and other structural steel work.

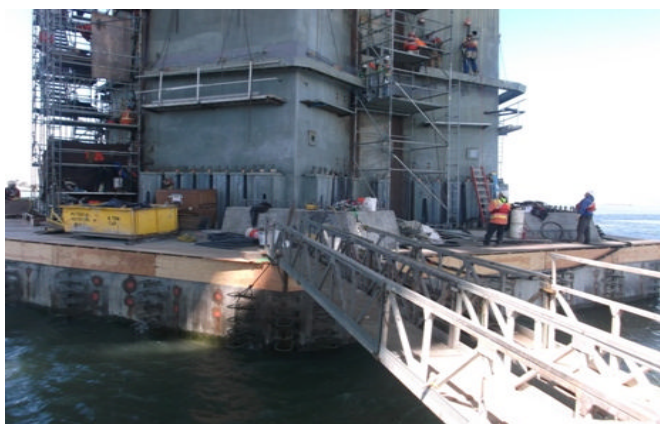
Scaffold&RingBream (4)

I arrived at the job site at about 10:30, at which time the CCC crew was erecting scaffolds on the South side of the tower in order to set-up a 10m long containment. The containment was needed for the blasting of electro-slag welded (ESW) joints "S" & "R". By the time this crew of 6 people departed at 15:30, the containment was almost complete. This work took much longer than it was warranted due to the fact that during the erection of the scaffold the iron workers were erecting the ring beam. The close proximity of the iron workers with the CCC crew and the interference of the ring beam with the scaffold was not the most prudent approach, as it created a hazardous situation. For details on the ring beam installation, refer to Sami Daouk's report.
